RE: Crystal Lake Avenue Property – Mine Evaluation, Crystal Lake Ave NW, Canal Fulton, Ohio (ST&I PROJECT No. G24-12777)

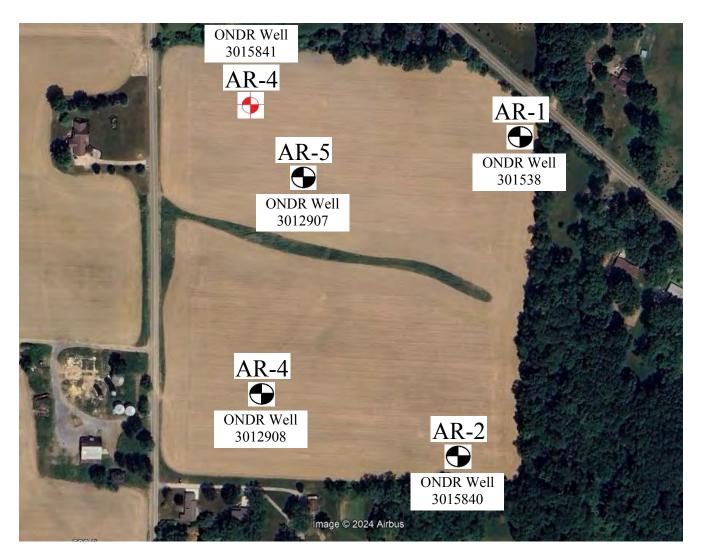
BORING LOCATION PLAN

Field Testing / Site Observations: On June 21st, the writer visited the site to assess general geological conditions, and signs of past or current surface subsidence. Between June 21st and 25th three air rotary test holes, as position of the attached "Boring Location Plan", were advanced with an all-terrain air rotary drill rig to depths of 147 to 200 feet below the ground surface. Test hole AR-2 (ODNR Well Log Number 3015840) was advanced first in the southeast corner of the subject property and identified 21 feet of clay and gravel soils underlain by 179 feet of interbedded shale and sandstone bedrock to the termination depth of 200 feet below the ground surface. Next, test hole AR-1 (ODNR Well Log Number 3015838) located near the northeast corner of the property encountered 42 feet of clay and gravel soils underlain by 158 feet of interbedded shale and sandstone to the termination depth of 200 feet below the existing ground elevation. A 1-foot thick seam of coal was penetrated at depths between 66 and 67 feet. Finally, test hole AR-3 (ODNR Well Log Number 3015841), located in the northwest section of the subject property found 30 feet of clay and gravel at the surface underlain by 111 feet of interbedded shale and sandstone extending to 141 feet below the existing ground surface where a 5-foot thick mine void was penetrated. The mine was flooded as determined by the expelled groundwater that contained coal fragments. The test hole terminated in 1 foot of "sound" bedrock (i.e., below mine floor) at the depth of 147 feet due to loss of air.

Mine Void EncounteredMine Void Not Encountered

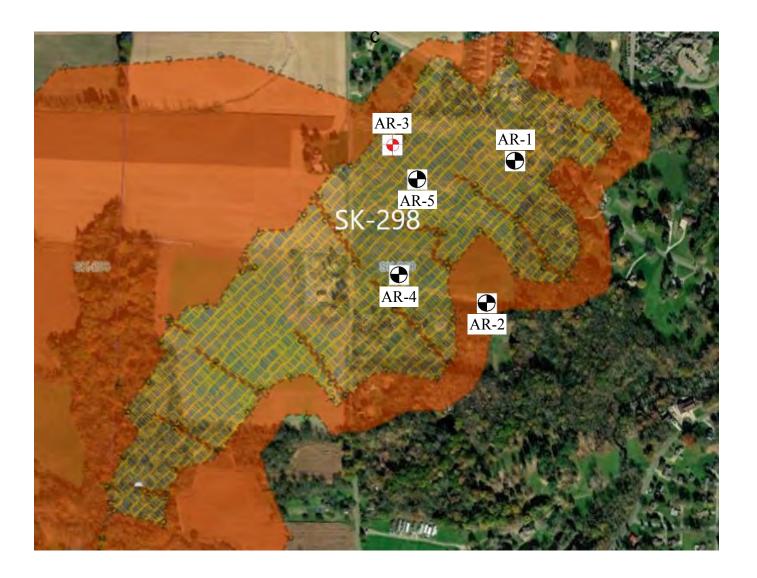
ODNR SK-298 Mine Map

According to the attached copy of mine map from the Ohio Department of Natural Resources web site, most of the property is underlain by mine SK-298 which is known as the "Rhodes and Companys Mine", operated by "Rhodes and Company", and was abandoned 1875. The mine map overlay by ODNR indicates the southeast corner of the subject property is not underlain by the abandoned mine.

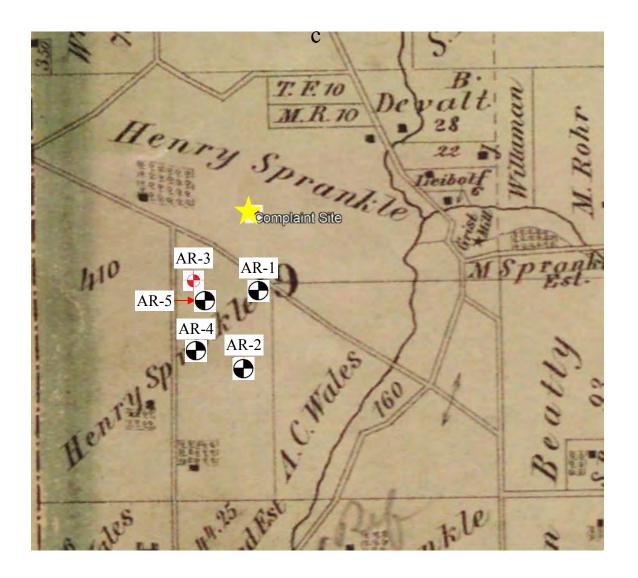
1875 Jackson Township Atlas Map

Ohio Department Of Natural Resources Mine Maps: Review of the original mine map does not provide many significant landmarks, save an indication of steep slope and RR line, likely a spur for the mining activities, with the mine mostly located in property owned by Henry Spangle with properties to the west owned by Henry Foltz and George Young. Review of the L. H. Everts and Co. Atlas of Stark County 1875 Jackson Township map shows property owned by Henry Spankle (likely Spangle) comprises most of section 19 within Jackson Twp. According to this historical map the Spankle property's north and west borders are the north and west section lines for section 19. This indicates the Spankle property was located both north and south of the road now known as Lafayette Drive NW, AKA Ohio SR-236. Reviewing these maps, it is possible the actual mine map could be positioned with the northwest corner of the Henry Spangle property at the northwest corner of the Spankle property on the 1875 map. Which would position the underground mine outside of the footprint of subject property.
