RE: Crystal Lake Avenue Property – Mine Evaluation, Crystal Lake Ave NW, Canal Fulton, Ohio (ST&I PROJECT No. G24-12777)

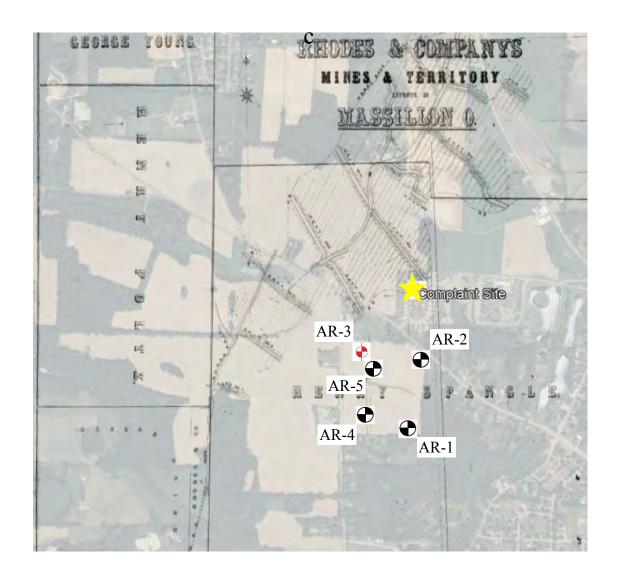
Rhodes Mine Map Reposition to Match NW Corner

According to the attached copy of mine map from the Ohio Department of Natural Resources web site, most of the property is underlain by mine SK-298 which is known as the "Rhodes and Companys Mine", operated by "Rhodes and Company", and was abandoned 1875. The mine map overlay by ODNR indicates the southeast corner of the subject property is not underlain by the abandoned mine.

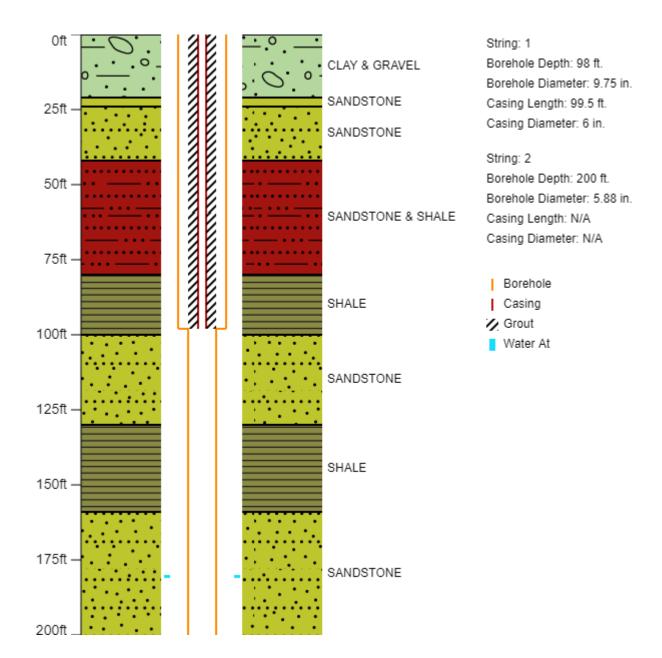
AR-3 WATER WELL LOG

- 2) The bedrock thickness between the overburden soil and mine void at AR-3 is 111 feet.
- 3) The mine void at AR-3 was found at depths between 141 to 146 feet below the ground surface

- 4) The mine was found to be flooded;
- 7) Sandstone bedrock bridges subsidence better than shale bedrock;
- 8) Shale roof rock less than 10.0 feet in thickness will fail quickly;

With regards to final foundation plans especially for the house in the northwest section of the property where the mine void was encountered, it is recommended to construct 3.0+/- feet thick trench footings (with 2 - #5 top / bottom rebar) as opposed to typical strip footings as the former would be rigid enough to limit any potential cosmetic/structural damage to building and allow ample time to stabilize random isolated areas of subsidence.
